# MULTIPLE BELZONA REPAIRS TO 72" DIAMETER STEEL PIPE EMBEDDED IN CONCRETE

Customer Location: Nuclear Power Plant in New Jersey

Service water system piping (condenser outlet pipe to cooling tower)

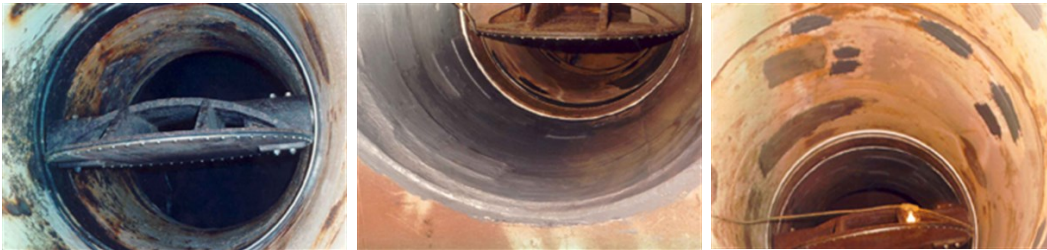
The 72" diameter steel pipe embedded in concrete was corroded and had developed through wall leaks.

- \* View of the eroded pipe before work commenced ,
- \* Completed application to steel pipe ,
- \* Overall view of repair area showing patch repairs to concrete pipe and application to steel pipe in background ,

Application was carried out in accordance with Belzona Know-How Leaflets VPF-1, VPF-2 and FPA-6.
