Belzona Repairs a Floating Hose

ID: 7511

Industry: Oil & Gas
Application: SOS-Ships and Offshore Structures

Customer Location: Holyhead, Wales
Application Date: July 2017

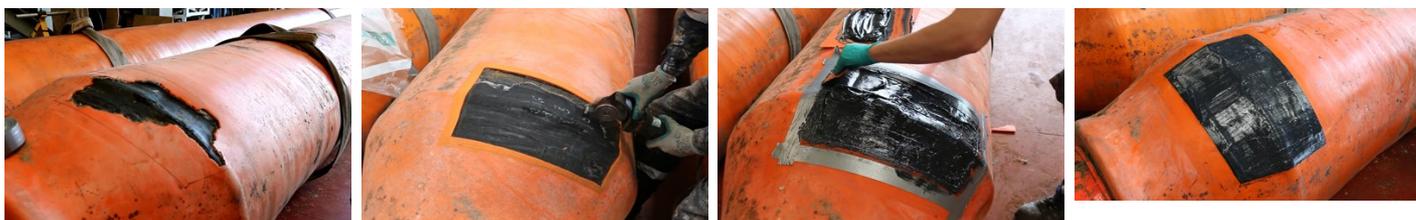
Photograph Descriptions

The rubber reinforced covers and flotation/insulation on fuel hoses was damaged. Thought to be caused by the ships propeller during fuel loading and unloading.

- * 1. Damaged rubber. ,
- * 2. Surface preparation. ,
- * 3. Application in progress. ,
- * 4. Finished application. ,

The repair was carried out in accordance with Belzona Know-How System Leaflet SOS-12.
