BELZONA REBUILDS AND PROTECTS KORT NOZZLES

Customer Location: *Tug boat operator - Vancouver, BC
Canada*

Tug boat kort nozzles

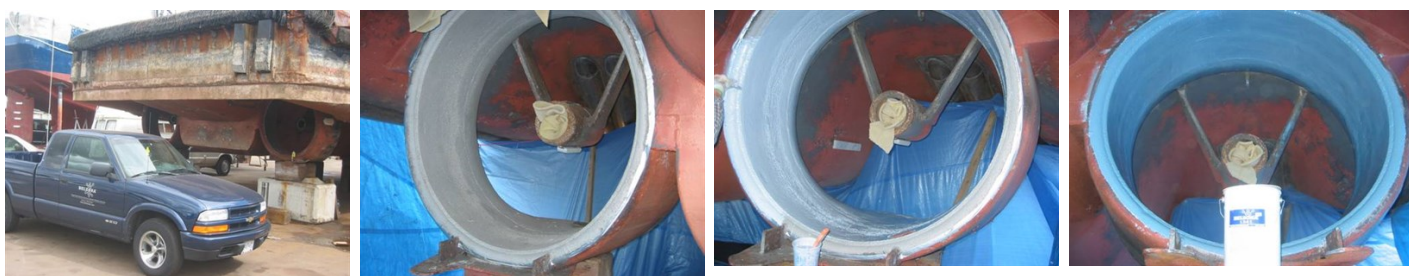
Kort nozzles badly eroded.

- * View of tug boat in dry dock. ,
- * View of one of the blasted nozzles. ,
- * Application of first coat of Belzona® 1341 with application of Belzona® 1311 to fill the voids and depressions in progress. ,
- * Second coat of Belzona® 1341 applied to complete the application. ,

Application was carried out in accordance with Belzona Know-How System Leaflets SOS-1 & SOS-2.

Customer had given serious consideration to relining nozzles with a stainless steel insert. This, however, posed a clearance problem. The Belzona solution was the quickest, easiest and most economical solution of the two.
