# Belzona Coating For Internal Of Closed Drain Drum

**Industry:** Chemical & Petrochemical  
**Application:** TCC-Tanks and Chemical Containment Areas  
**Substrate:** Grit Blasted Carbon Steel SA516-70  
**Products:** \* Belzona 1391T ,

**Customer Location:** Refinery, Indonesia  
**Application Date:** July 2017

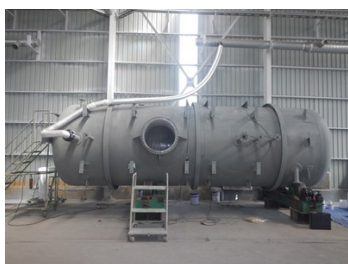
\* 1. General view of the vessel during grit blasting 2. 1st coat of Belzona 1391T almost completed 3. high voltage pinhole detection under-way 4. Completed application of Belzona 1391T 2 coat system ,

Application was carried out in accordance with Belzona Know-How System Leaflet TCC-5 and TCC-16. Nozzle inserts were manufactured and bonded into small diameter nozzles to ensure continuity of protection. The coating process was carried out with the vessel on rollers which avoided all overhead application work, and reduced application time considerably.
