# BELZONA SUPERWRAP II SUCCESSFULLY TACKLES AN EMERGENCY PIPE LEAK REPAIR

Industry: *Power* Customer Location: *Power Plant, Florida, USA*  
Application: *VPP-Valves, Pipes and Fittings* Application Date: *August 2017*  
Substrate: *Fiberglass*  
Products: *\* Belzona 1212 Belzona Superwrap II composite repair system: Belzona 9381 - reinforcing fabric Belzona 1982 - impregnation resin Belzona 9382 - release film ,*

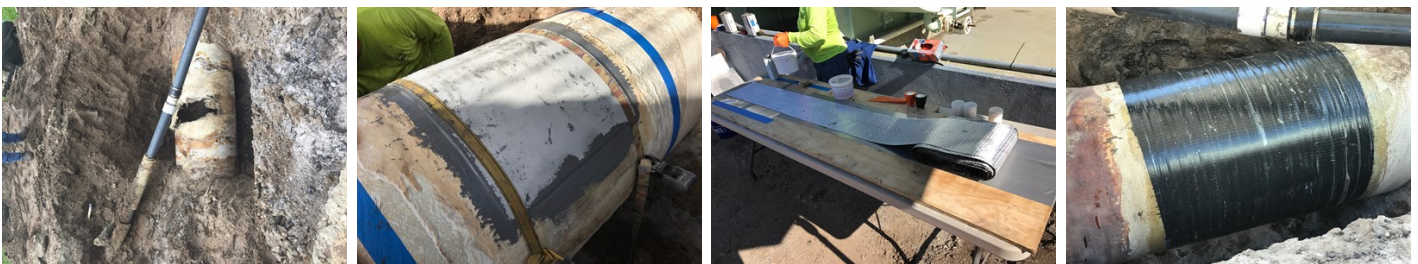
## Photograph Descriptions

*Rupture in the water pipe line causing erosion of the surrounding area and the road above the line.*

\* 1. Rupture in the water pipe line. 2. Metal plate bonded with Belzona 1212 to create a bridge for the wrap. 3. Wetting out Belzona 9381 (reinforcing wrap) with Belzona 1982 (resin). 4. Complete application of the Belzona Superwrap II composite repair system. ,

First, the rupture had to be opened wider to pump out all of the water from the pipe. The surface was then blasted to prepare the right profile to ensure optimal adhesion with the Belzona products. Due to the size of the rupture, a metal plate was used to bridge over the rupture. Belzona 1212 was used to bond the plate to the substrate. Belzona 9381 (reinforcing fabric) was then wetted out with Belzona 1982 and wrapped around the circumference of the pipe. Belzona 9382 (release film) was then applied over the wrap to secure it in place and to avoid air entrapment by exuding excess resin.
