BELZONA SHAFT REPAIR PREVENTS LOSS IN REVENUE

ID: 7526

Industry:
Application: MPT-Mechanical Power Transmission

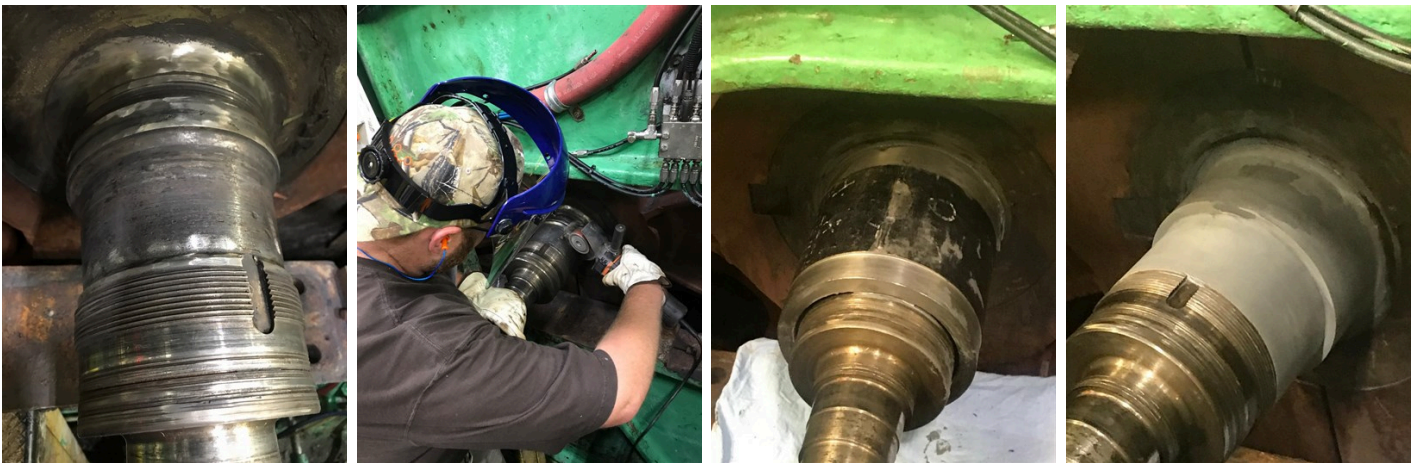
Photograph Descriptions

Failed bearing grooved the shaft so that the machine would not run. Shaft holds approximately 25000 pounds. Customer had replaced a shaft on similar machine and it took 3 weeks of round the clock maintenance teams to get it back up and running. The Belzona solution could be done in a day and save them potentially hundreds of thousands of dollars.

- * 1. Damaged shaft. ,
- * 2. Preparing the repair area with a bristle blaster. ,
- * 3. Former injected with Belzona 1321. ,
- * 4. Completed repair. ,

Bearing failure had caused significant damage to the main drive shaft on carton forming machine. Replacing shaft would take up to 21 days of round-the-clock work.

The shaft repair was carried out in accordance with Belzona System Leaflet MPT-2. A custom former had been made at a machine shop. Belzona 9411 was used to make sure that Belzona 1321 would not stick to the former. Belzona 1321 was injected into the former and allowed to cure.
