Belzona Provides Internal Lining to New Slurry Thickener

ID: 7527

Customer Location: Chemical Plant, Italy
Application Date: September 2017

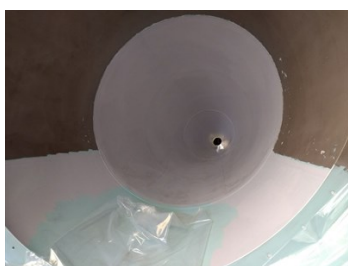
- * 1. Internal view ,
- * 2. DFT Inspection ,
- * 3. Spark test ,
- * 4. Completed application ,

Application carried out in accordance with Belzona System Leaflet SHM-13.
