# BELZONA BOND HATCH FLANGES

ID: 7528

Industry: Marine  
Application: GSS-Gaskets, Seals and Shims  
Substrate: Mild Steel  
Products: \* Belzona 1111 (SuperMetal) ,

Customer Location: Cape Town, South Africa  
Application Date: September 2017

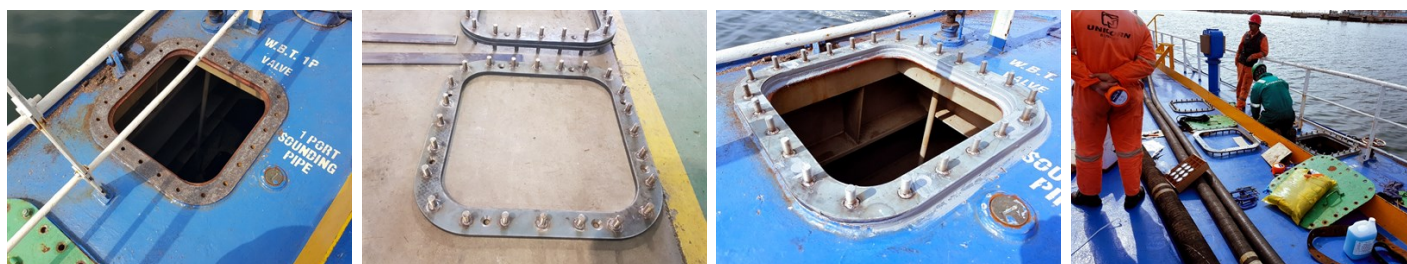
- \* Damaged Hatch Flanges ,
- \* Flanges removed and prepared ,
- \* Hatch rebonded onto the vessel with Belzona 1111 ,
- \* Scope of work, all hatches were rebonded. ,

The manway hatches on this vessel had suffered from corrosion damage and began to disbond from the deck.

Application was carried out in accordance with Belzona System Leaflet GSS-8. Blasting and grinding was not permitted on the vessel, so a Bristle Blaster was used to prepare the surface and the hatches taken off-site and grit blasted.

Belzona was selected because it was the only product that could cold bond the flanges in place with no hot work, solving the problem with minimal downtime and no safety concerns.
