# Belzona Seal-A-Tank Success in Service for Over 13 Years

ID: 7530

Customer Location: Refinery, West France  
 Application Date: 2004

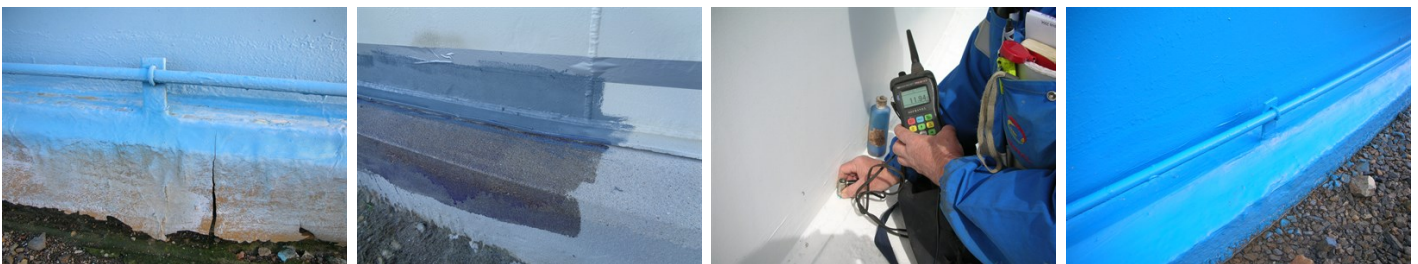
## Photograph Descriptions

The refinery had an existing tank base sealing system in place which was failing due to its rigidity. The failed system had resulted in water ingress, causing corrosion at the base of the tank and required protection for the long term.

- \* 1. Failing system that needed replacing. ,
- \* 2. Surface conditioned. ,
- \* 3. Testing the annular rim through Belzona 3111. ,
- \* 4. Seal-a-Tank system still in an excellent condition. ,

Application completed in accordance with Belzona Know How System Leaflet TCC-4. Surface correctly prepared and conditioned before the application of Belzona 3111 to provide waterproof protection at the base of the tank.

This application was inspected three years after and found to be in good condition with no signs of corrosion. Subsequently, it was reinspected in 2017 and still found to be in excellent condition. The customer was very pleased with the application and its longevity in service. In addition, the customer was pleased because, unlike competitor systems, it is possible to inspect the thickness of the annular rim through Belzona 3111.
