# BELZONA 4301 PROTECTS FLANGE FACE FROM SULFURIC ACID

ID: 7531

Industry: Food & Drink  
Application: VPF-Valves, Pipes and Fittings  
Substrate: Mild Steel  
Products: \* Belzona 4301 (CR1 Hi-Build) ,

Customer Location: Pharmaceuticals Company, Scotland, UK  
Application Date: November 2016

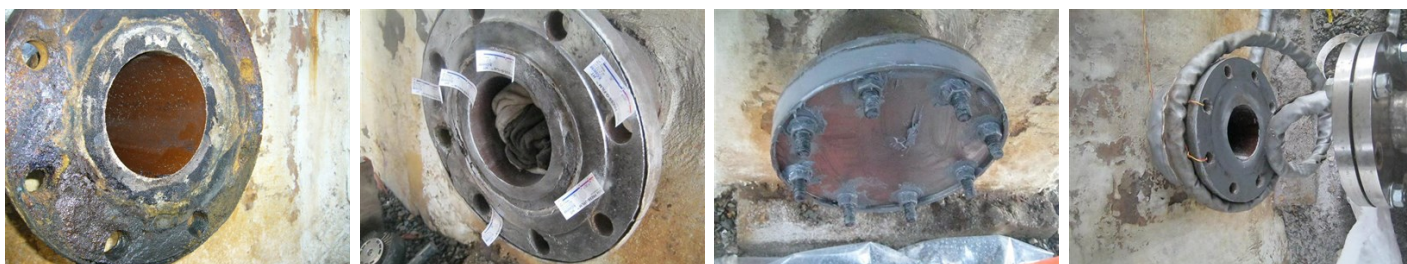
## Photograph Descriptions

Cutting and welding was deemed to be unacceptable due to the damage that would be caused to the lining inside the nozzle and the safety concerns. A flange face and surrounding bolts had become corroded from contact with Sulphuric Acid. The loss of metal in the flange was causing significant leaks around the flange. This led to environmental and safety concerns.

- \* 1 - Damaged flange face & bolts ,
- \* 2 - Flange prepared & profile checked ,
- \* 3 - Former bolted in position ,
- \* 4 - Former removed, bore dressed down & induction heat coil in place ,

The face was prepared using an MBX bristle blaster. A blank flange was used to form the face using a modified version of Belzona system leaflet VPF-13. Time was an issue so induction heaters were brought in to force cure the product. The cured product was machined back once the former was removed.
