Belzona Repairs and Protects Water Softener

ID: 7533

Customer Location: Scotland, UK, Pharmaceutical Industry
Application Date: January 2017

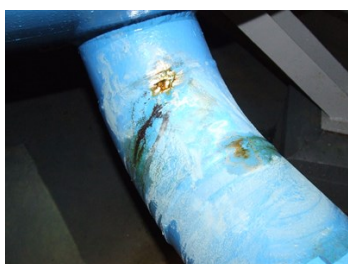
Two welded areas on this pipe had experienced internal corrosion from the internals resulting in pin hole leaks. The water softener contained Brine & ran at approximately 10 degrees C.

Leaking area

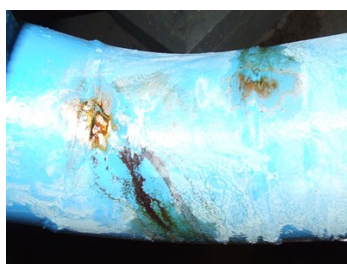
Close up of leak

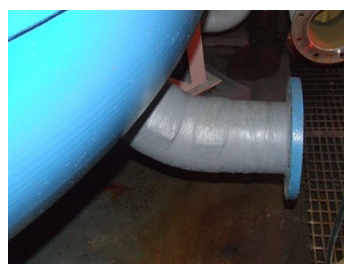
Plate bond & wrap applied

Application was carried out in accordance with a modified version of Belzona System Leaflet VPF-11. Belzona 1321 was applied as a two coat system to the internals. Belzona 1161 and Belzona 9341 reinforcement tape were applied to the external as a composite wrap system.

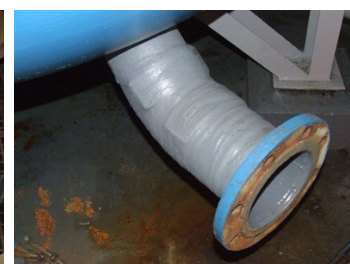
Completed application
