Belzona Repairs and Protects Water Softener

ID: 7533

Industry: *Chemical & Petrochemical*
 Application: *VPF-Valves, Pipes and Fittings*
 Substrate: *Carbon steel*
 Products: *Belzona 1321 (Ceramic S-Metal),
 Belzona 1161 (Super UW Metal),*

Customer Location: *Scotland, UK, Pharmaceutical Industry*
 Application Date: *January 2017*

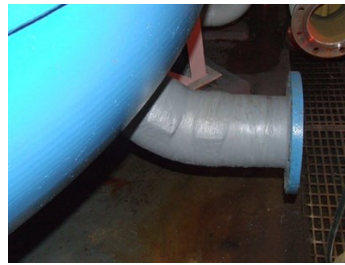
Plate bond & wrap applied

Application was carried out in accordance with a modified version of Belzona System Leaflet VPF-11. Belzona 1321 was applied as a two coat system to the internals. Belzona 1161 and Belzona 9341 reinforcement tape were applied to the external as a composite wrap system.

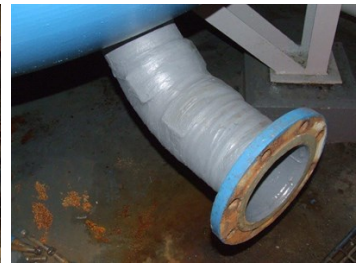
Completed application

Cutting and welding was undesirable due to the environment around the pipe and the safety regulations in place. This traditional method would not have prevented the original issue of corrosion from reoccurring. The Belzona system was installed & cured using external heat to further reduce downtime. This system will prevent the corrosion reoccurring in the future, extending the lifetime of the equipment. The application was inspected in July 2022 & was still in good condition.
