PROTECTING HVAC DUCTWORK WITH BELZONA

Solution required to seal and protect weathered ductwork insulation.

Insulated heating and ventilation ductwork on a university roof.

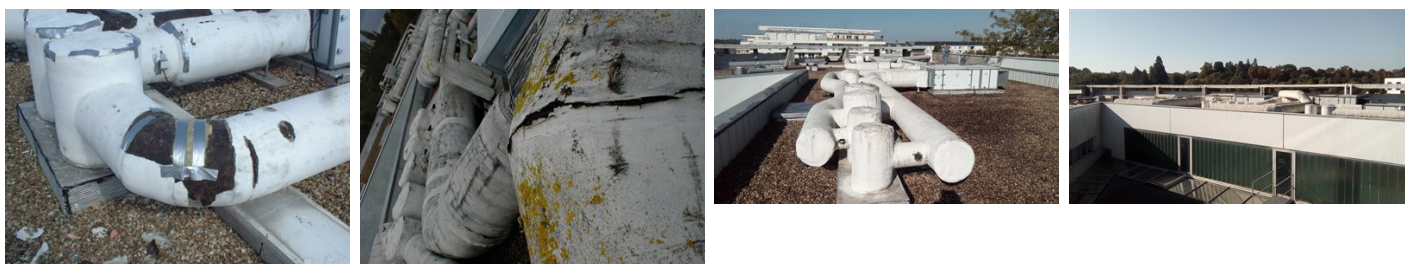
Photograph Descriptions

* 1. Damaged insulation 2. Close up of the damage 3. Belzona repair after 14 years in service 4. Belzona repair after 14 years in service ,

Application was carried out in accordance with Belzona System Leaflet VPF-12.

Belzona 3211 offers outstanding protection from the elements, including UV exposure. It is micro-porous and will prevent liquid from penetrating through it while allowing any moisture to evaporate, so maintaining thermal efficiency and reducing CUI. This application was photographed in 2017, after 14 years in service. Still in perfect condition.
