PROTECTING HVAC DUCTWORK WITH BELZONA

ID: 7534

Industry: Heating, Ventilation & Air Conditioning
 Application: VPF-Valves, Pipes and Fittings
 Substrate: Various insulation materials
 Products: * Belzona 3211 (Lagseal) ,

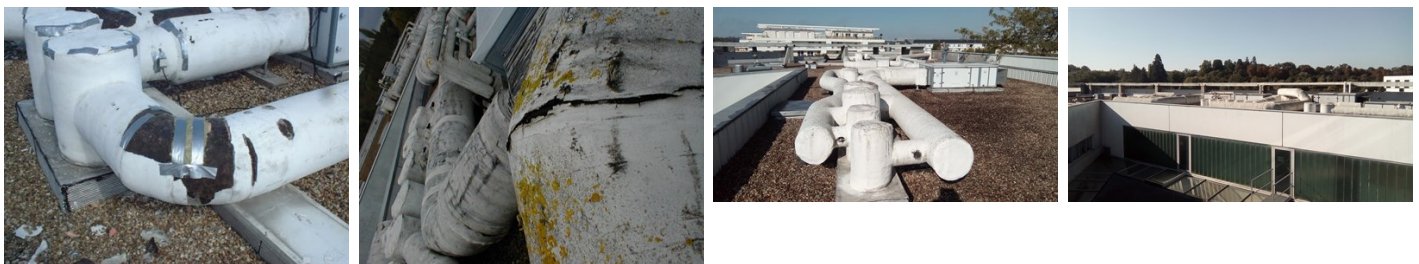
Photograph Descriptions

Solution required to seal and protect weathered ductwork insulation.

* 1. Damaged insulation 2. Close up of the damage 3. Belzona repair after 14 years in service 4. Belzona repair after 14 years in service ,

Insulated heating and ventilation ductwork on a university roof.

Application was carried out in accordance with Belzona System Leaflet VPF-12.

Belzona 3211 offers outstanding protection from the elements, including UV exposure. It is micro-porous and will prevent liquid from penetrating through it while allowing any moisture to evaporate, so maintaining thermal efficiency and reducing CUI. This application was photographed in 2017, after 14 years in service. Still in perfect condition.
