BELZONA PROTECTS LEADING EDGE OF WIND TURBINE BLADES

ID: 7537

Industry: Power
Application: FBC-Fans, Blowers and Compressors

Customer Location: Québec, Canada
Application Date: Summer 2017

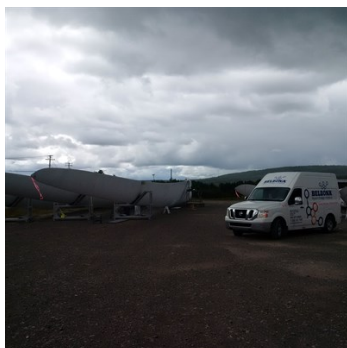
- * 1. Belzona personnel arriving on site to support the application. ,
- * 2. Belzona 1341 being applied by roller in the outlined and prepared LEP area. ,
- * 3. & 4. LEP coating complete with Belzona 1341 ,
- * ,

The application was carried out in accordance with a modified version of Belzona Know-How System Leaflet FBC-1. The blades were brought down and coated on the ground in a large shop area as they were going to do general maintenance on them. The pitting and loss of surface on the leading edge was resurfaced in with a filler product and rebuilt to dimensions. The outlined Leading Edge gel coated surface area was sanded down with a mechanical sander with 80 grit sandpaper and cleaned down with a rag and non-residual solvent cleaner. One coat of Belzona 1341 was applied by roller to an average mil thickness of 12 mils.

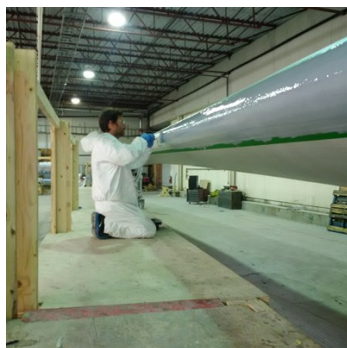
Erosion had started on the leading edge of the blades compromising the performance/energy output and probable life expectancy of the wind turbines. If not properly dealt with, the problem could propagate into a very serious issue in the upcoming years. The Customer had used a different LEP coating in the past and was not happy with the performance and difficulty of application.

After some years in service the leading edge on the blades of the wind turbines were showing deterioration from rain/environmental erosion. As a preventive step, the asset owner wanted to apply an LEP (Leading Edge Protection) coating on the blades over the summer. The number of blades was near to 100.
