BELZONA REPAIRS 4 YEAR OLD PRIMARY SETTLEMENT TANK

ID: 7538

Customer Location: Waste Water Company, England
Application Date: August 2017

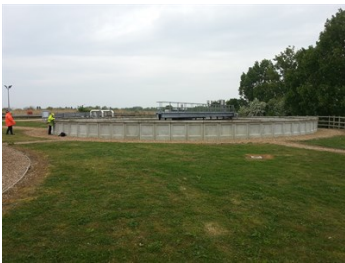
- * 1. The large PST (Primary Settlement Tank) ,
- * 2. Damaged and broken expansion joints before. ,
- * 3. Damaged joint being rebuilt with B4111 creating new expansion gap using wooden formers. ,
- * 4. Completed expansion joints after installing Belzona 2211 ,

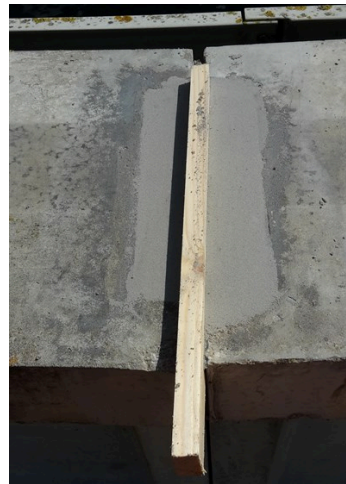
Shortly after the PST tank was constructed 4 years ago, the expansion joints between the 82 x top blocks failed and so were repaired several times by the client using cementitious materials which had again failed. This caused problems for the boom arm to rotate correctly and some of the top horizontal blocks had come loose causing them to rock when the boom arm wheel passed over them

Application was carried out according to Belzona Know-How System Leaflets TCC-11 and TCC-12. All the loose and broken material from the 82 x joints and other areas on the rim were removed. The damaged areas were then rebuilt with Belzona 4111 to create new expansion joint gaps using a wooden former. Belzona 2211 was installed in all the expansion joints both horizontally across the top and up both sides to create a flexible joint. A fillet of Belzona 4111 was installed underneath the horizontal blocks and onto the vertical concrete panels all around the tank to prevent the top rim blocks from rocking
