BELZONA 1212 SEALS LEAKING COPPER GUTTERS AT UNIVERSITY

ID: 7539

Industry: *Buildings & Structures*
Application: *RPA-Roof Problem Areas*
Substrate: *Copper*
Products: ** Belzona 1212 ,*

Customer Location: *College, Cambridge, England*
Application Date: *August 2017*

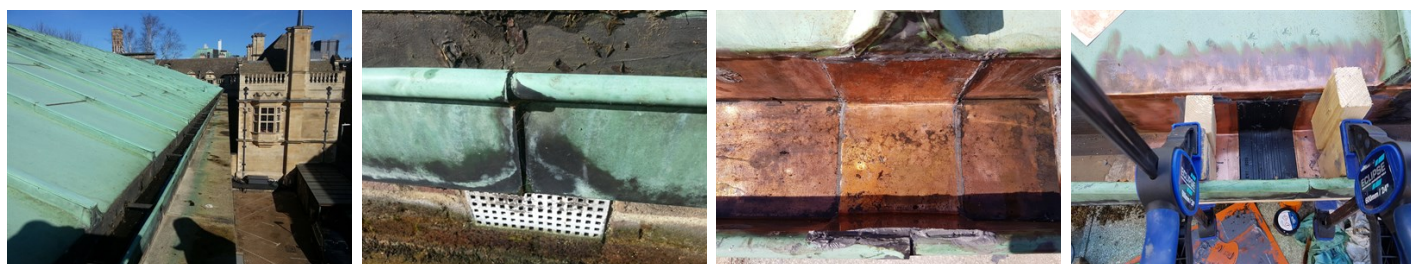
Photograph Descriptions

The 56 joints in the copper gutters had been constantly leaking for almost 40 years causing unsightly staining on the building structure underneath the joints.

- * 1.The College Building showing copper gutter and stains on stonework ,
- * 2.Typical leaking gutter joint ,
- * 3.Gutter joint cleaned and sealed inside with new copper plate bonded on with Belzona 1212 ,
- * 4.Flexible system being installed over every 4th joint bonded on with Belzona 1212 ,

Application was carried out in accordance with a modified version of Belzona System Leaflet TCC-1. All loose material in the 56 joint areas was removed to create a really clean and bright copper surface. New 200mm copper strips were cold bonded across the joints using Belzona 1212 to permanently seal the joints. Over every 4th joint a flexible system (supplied by the customer) was bonded using Belzona 1212 in the same way.
