BELZONA REPAIRS AND PROTECTS MULTIPLE BALCONIES ON LARGE HOUSING SITE

ID: 7540

Application: FPA-Floor Problem Areas

Application Date: April -July 2017

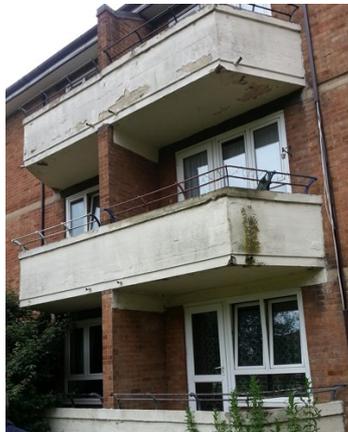
The existing coating on all the concrete balconies was flaking off and in many areas the concrete was broken and cracked where moisture has rusted the steel reinforcing bars inside the concrete structure. The concrete base of the balconies was a slip hazard when wet.

- * 1.The block of Flats ,
- * 2. Damaged Balconies ,
- * 3. Typical problem on a balcony with current coating coming off and damaged concrete exposed ,
- * 4. Balconies after the Belzona repairs and coating has been completed ,

Application was carried out in accordance with a modified version of Belzona System Leaflet FPA-1 and FPA-8. All broken and damaged areas of concrete were repaired with Belzona 4141. The balcony walls and underneath surfaces were coated with Belzona 5151. A non-slip surface was created on the balcony floors with Belzona 5811 blinded out with aggregate.
