BELZONA REPAIRS KAMEWA IMPELLER DUCT

Kamewa jet drive on high speed passenger ferry operating on lake Como

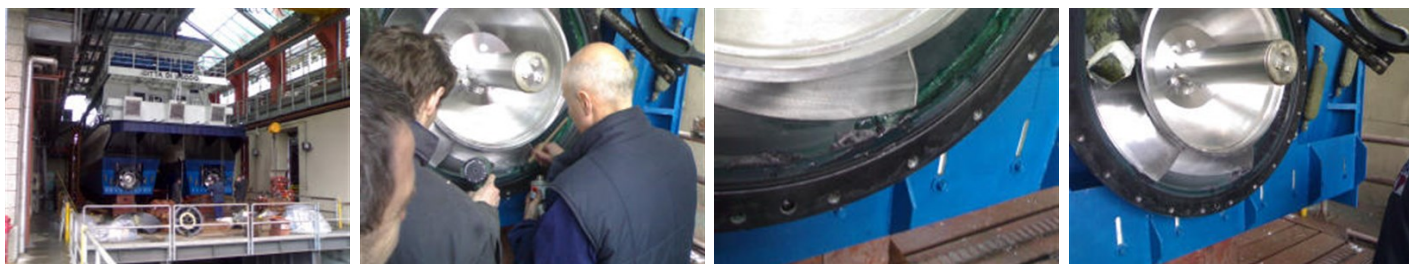
Photograph Descriptions

Deep erosion on the impeller duct lining

- * View of the high speed ferry ,
- * Conditioning the substrate underway ,
- * Close up of the application ,
- * Completed application ,

The application was carried out in accordance with Belzona Know-How System Leaflet TCC-3.

The Belzona repair was carried out without having to dismount the entire propulsion unit saving and estimated €150,000 and ensuring minimal disruption to normal service. Belzona® 2311 has excellent adhesion to the polyurethane lining together with excellent cavitation resistance to ensure a long term effective repair.
