# ROOF OF AN ART DECO BUILDING SAVED WITH BELZONA

**Industry:** Buildings & Structures  
**Application:** RPA-Roof Problem Areas  
**Substrate:** Bitumen felt  
**Products:** \* Belzona 3111 (Flexible Membrane) ,

**Customer Location:** Lancashire, England, UK  
**Application Date:** 2016

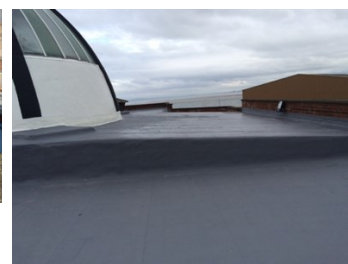
The roof is a large expanse with several separate roof areas on different levels. There were numerous leak areas through the existing roofing felt that required repair to prevent permanent damage to the wonderful interior which is still used for numerous events on a regular basis including ball room dancing.

- \* 1. Overview of the building ,
- \* 2. One small section of the roof before ,
- \* 3. The same small section after application of Belzona 3111 ,
- \* 4. Belzona 3111 coated section close to the dome area ,

The application was carried out in accordance with Belzona System Leaflets RPA-1,6,8 & 10
