BELZONA SOLVES CORROSION ISSUE ON SHEET EDGE ROOFING SECTIONS

ID: 7551

Customer Location: *Leisure Center, Fleetwood, England, UK*
Application Date: *2016*

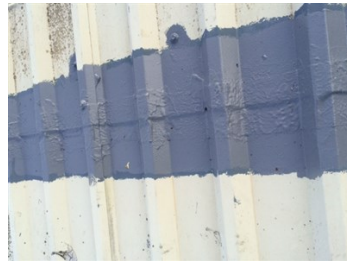
The area is close to the coast making corrosion of metal a real problem on exposed areas of mild steel. This large metal roof was suffering significant sheet edge corrosion damage.

- * 1. Overview of roof area affected by sheet edge corrosion ,
- * 2. Close of of a badly damaged area ,
- * 3. Close up of a repaired area ,
- * 4. Overview of repaired roof area ,
- * ,

The application was carried out in accordance with Belzona Know-How System Leaflet RPA-1.
