# BELZONA SOLVES CORROSION ISSUE ON SHEET EDGE ROOFING SECTIONS

Industry: Buildings & Structures  
Application: RPA-Roof Problem Areas  
Substrate: Steel  
Products: \* Belzona 3131 (WG Membrane) ,

Customer Location: Leisure Center, Fleetwood, England, UK  
Application Date: 2016

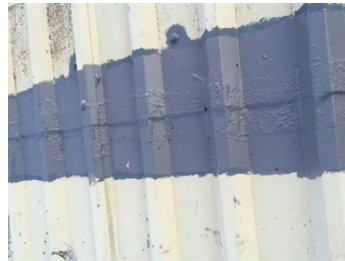
The area is close to the coast making corrosion of metal a real problem on exposed areas of mild steel. This large metal roof was suffering significant sheet edge corrosion damage.

- \* 1. Overview of roof area affected by sheet edge corrosion ,
- \* 2. Close up of a badly damaged area ,
- \* 3. Close up of a repaired area ,
- \* 4. Overview of repaired roof area ,
- \* ,

The application was carried out in accordance with Belzona Know-How System Leaflet RPA-1.
