# BELZONA REPAIRS POROUS GEARBOX

ID: 7552

Industry: Fluid Flow  
Application: ENC-Engines and Casings  
Substrate: Mild Steel  
Products: \* Belzona 5892 ,

Customer Location: Pump Manufacturer, UK  
Application Date: June 2017

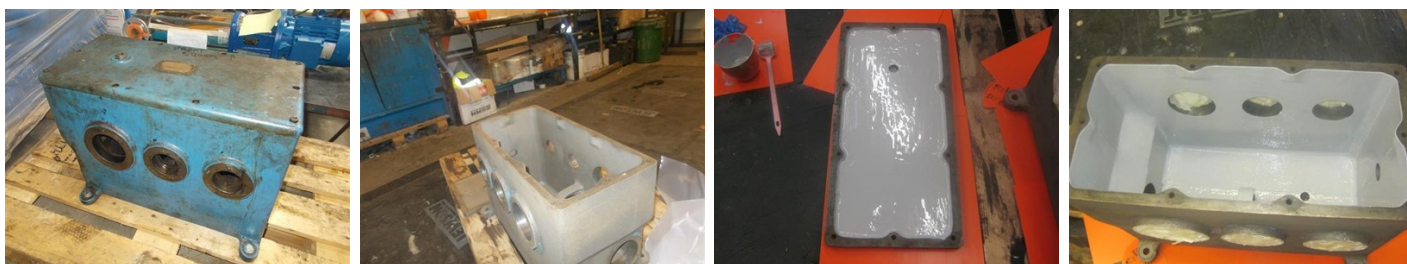
*The gearbox was found to be porous and was leaking oil. This loss of oil was hampering the proper operation of the gearbox. The exact areas which were porous would be difficult to identify. The only sure way of sealing the internals was by coating with an impermeable barrier.*

- \* 1. Gearbox disassembled ,
- \* 2. Grit blasting complete ,
- \* 3. Lid of gearbox coated ,
- \* 4. Body of gearbox coated ,

Application was carried out in accordance with a modified version of Belzona Know-How System Leaflet ENC-1. The gearbox was first grit blasted, then a two coat system of Belzona 5892 was applied to the internal areas.
