# Belzona repairs pitted engine cylinders

Customer Location: Shipyard, Glasgow, Scotland  
Application Date: May 2017

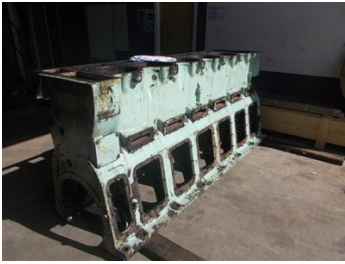
- \* 1. The Engine block ,
- \* 2. Close up of pitting damage ,
- \* 3. Areas after grit blasting ,
- \* 4. Application of Belzona 1111 ,

An engine block for a tugboat was found to have pitting around the cylinders.

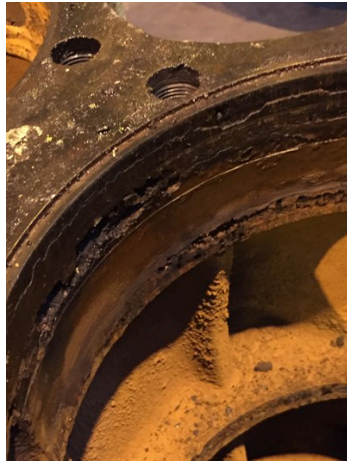
*Weld repairs would be problematic & time consuming on this area. They would also not solve the original issue of corrosion.*

The Belzona repairs rebuilt the lost metal with no risk of distortion or further damage to the casing. Belzona 1111 being corrosion resistant ensures a long term repair free from the original corrosion problems.
