# BELZONA PROTECTS FLANGES FOR GAS WORKS

ID: 7554

Customer Location: Glasgow, Scotland  
Application Date: June 2017

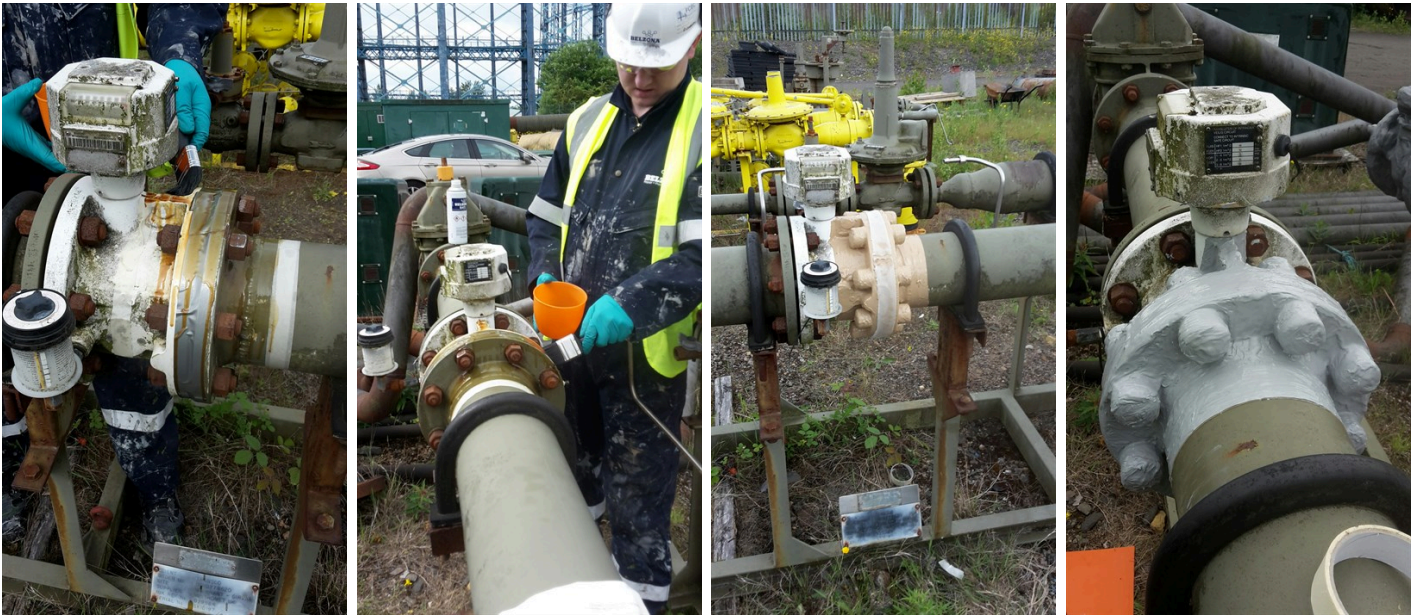
## Photograph Descriptions

- \* 1. Flange with void taped ,
- \* 2. First coat during application ,
- \* 3. First coat applied ,
- \* 4. Second coat applied ,

A section of pipework had an exposed flange that was deemed to be susceptible to corrosion.

Application was carried out in accordance with Belzona Know-How System Leaflet GSS-11.

The Belzona solution allows the flange to be protected and then accessed when required for maintenance or inspection. Traditional painting of the flange would leave it inaccessible and may not completely encasulate the flange potentially allowing corrosion to still occur.
