Belzona saves a cement silo lid

ID: 7555

Customer Location: Concrete products manufacturer,
Bedfordshire, UK

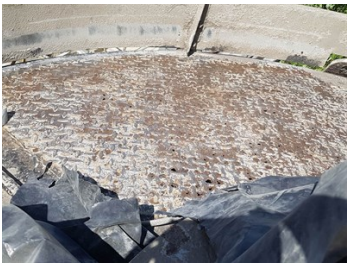
Any moisture ingress will ruin the stored materials. The customer had noticed problems and after inspecting found that the lid was severely corroded and was letting in rainwater. The silo is 11 metres high, to replace the lid would be logistically very difficult and incredibly expensive.

- * 1. The silo lid at the start of the repairs ,
- * 2. A closer look at the damage ,
- * 3. The lid repaired with Belzona 1111 plate bonding techniques ,
- * 4. The finished lid after application of Belzona 5811 ,
