# BELZONA PROTECTS THE SURFACE OF MAIN WATER-PUMP INLET MANIFOLD

ID: 7556

Customer Location: Mining Company, Norway  
Application Date: September - October, 2017

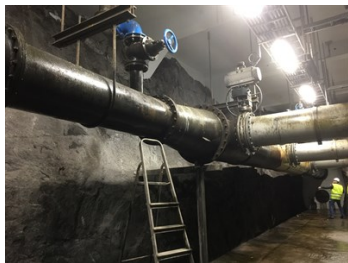
Severe corrosion on these pipes externals had developed over 50 years, several unsuccessful attempts to protect the pipe had been started and ended without fully protecting the surface over the last 10 years. Humidity of 100%, constant running water from the surface and no possibility to gritblast meant conditions were not ideal for a coating application.

- \* 1. Overview of wet and condensed pipe manifold. ,
- \* 2. Surface preparation and first coat application ongoing. ,
- \* 3. First coat applied. ,
- \* 4. Final coat applied and cured. Constant running water from the surface can be seen. ,

Application was carried out in accordance with a modified version of Belzona Know-How System Leaflet CEP-4. Manual surface preparation was carried out using a combination of different tools. Belzona 1212 was used to fill deep pitting in the surface. Then, Belzona 5831 was applied for corrosion protection.
