BELZONA COMPLIANT SUPERWRAP REPAIR ON RISER WELLHEAD CASING

ID: 7558

Customer Location: Oil Field Operator, North Sea, Norway
Application Date: July 2016

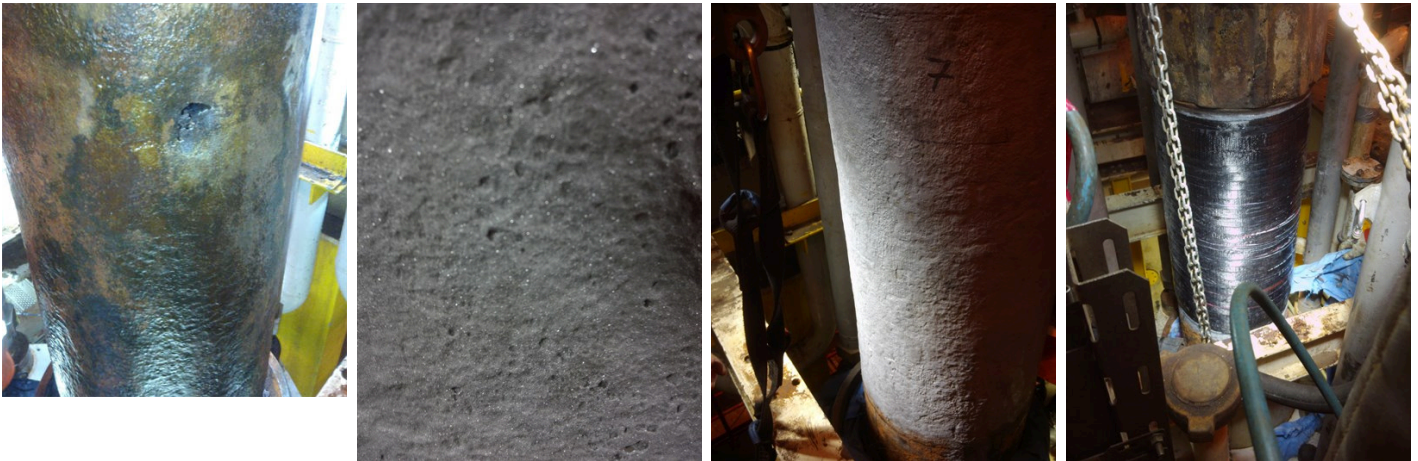
Severe corrosion on 17 years old 18" production riser on a North sea oil producing platform had resulted in a critical through wall defect. The riser was containing drillfluid as the oil production from the well been stopped recently. The drillfluid was leaking into the surrounding casing through the defect creating possible safety and environmental issues. The design parameters were: 20 years life expectancy, design temperature 55 deg Celcius and design pressure 1 MPa

- * 1. View of defect area. ,
- * 2. Gritblasting details. ,
- * 3. Gritblasting details and defect area patched and prepared using Belzona 1111. ,
- * 4. Completed SuperWrapII application. ,

The application was carried out in accordance with Belzona System Leaflet VPF-11. Following gritblasting, the defect area was patched with a layer of Belzona 1111. Immediately after this, the Belzona SuperWrap II system was installed in accordance with the calculated dimensions. After curing the application for 48 hours, a custom-made clamp was assembled to set the casing back to its former location and purpose, covering the SuperWrapII repair completely.
