BELZONA SUPERWRAP II REPAIRS 6" OPEN DRAIN SYSTEM

ID: 7562

Customer Location: Oil Field Operator, North Sea, Norway
Application Date: October 2016

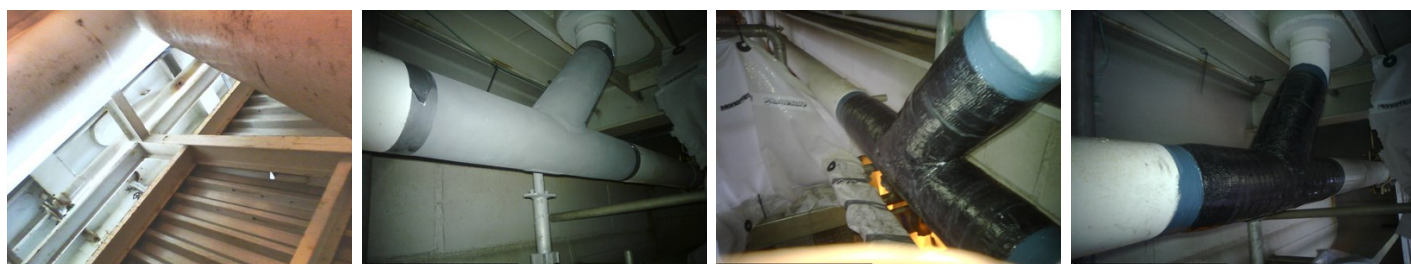
Photograph Descriptions

Internal corrosion caused multiple through-wall defects on the pipes.

- * 1. The defective pipe ,
- * 2. Pipe system following surface preparation ,
- * 3. Completed application detail ,
- * 4. Completed application ,

Multiple leaks on the oil rig's open drain system.

Application was carried out in accordance with Belzona System Leaflet VPF-11. Following gritblasting, the defect area was repaired and smoothed with a layer of Belzona 1111. The Belzona SuperWrap II system was installed in accordance with the pre-calculated design parameters for this T-section.
