# Belzona Repairs Concrete Footing

**Industry:** Buildings & Structures  
**Application:** TCC-Tanks and Chemical Containment Areas  
**Substrate:** Concrete and Steel Reinforcement  
**Products:** \* Belzona 4111 (Magma-Quartz),

**Customer Location:** Construction company, Slovakia  
**Application Date:** 2006

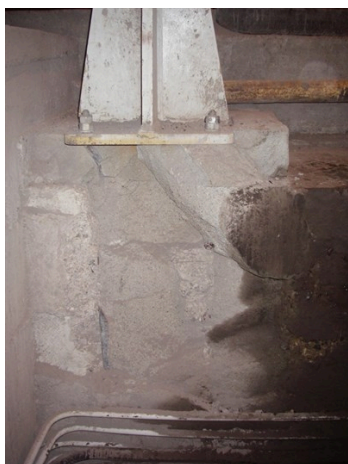
The footing was damaged by impact, this caused instability on the machine which meant it could not be used.

- \* 1. Destroyed concrete footing. ,
- \* 2. Belzona 4911 (TX Conditioner) application ,
- \* 3. Repair in progress ,
- \* 4. Belzona 4111 used to rebuild the base ,
