Belzona Repairs Concrete Footing

ID: 7564

Customer Location: Construction company, Slovakia
Application Date: 2006

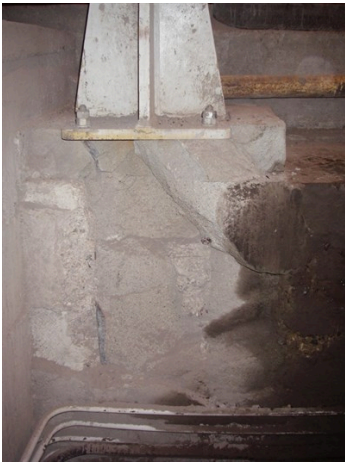
The footing was damaged by impact, this caused instability on the machine which meant it could not be used.

- * 1. Destroyed concrete footing. ,
- * 2. Belzona 4911 (TX Conditioner) application ,
- * 3. Repair in progress ,
- * 4. Belzona 4111 used to rebuild the base ,
