Belzona Protects Settlement Tank

ID: 7565

Industry: *General Industry*
Application: *TCC-Tanks and Chemical Containment Areas*
Substrate: *Steel*
Products: ** Belzona 5811 (Immersion Grade),*

Customer Location: *Pharmaceutical Company, Slovakia*
Application Date: *2010*

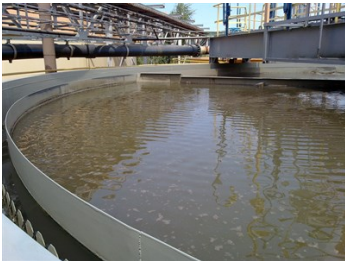
- * 1. Mixing Basin ,
- * 2. Extent of damage to the basin ,
- * 3. Blasting of the basin ,
- * 4. Completed application ,

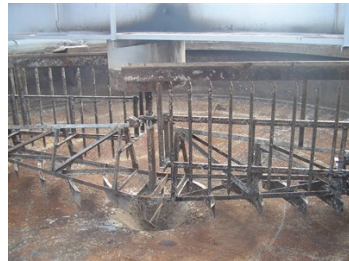
Erosion/corrosion damage was affecting the normal operation of the equipment
