Belzona Keeps The Cover On Annealing Oven

ID: 7566

Large annealing oven at a metal manufacturing plant.

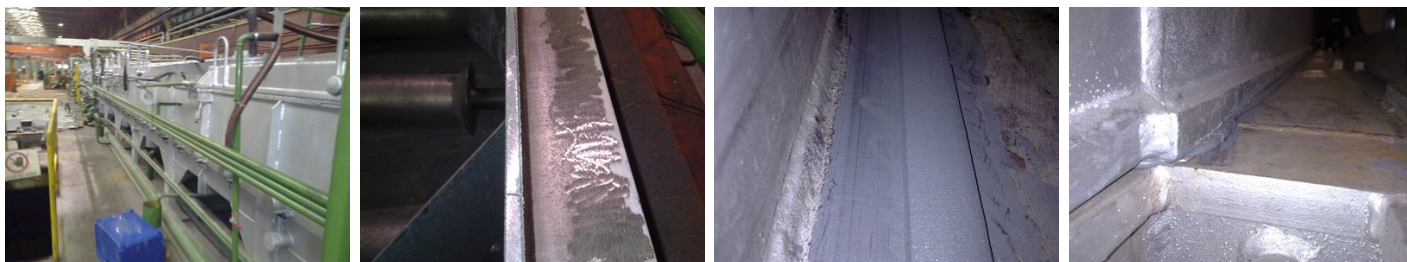
Photograph Descriptions

The cover had distorted and did not sit correctly on the base and caused a CO2 leakage.

- * 1. Annealing ovens ,
- * 2. Surface preparation ,
- * 3. Belzona 1121 application ,
- * 4. Cover replaced ,

Application was carried out in accordance with Belzona Know-How System Leaflet ENC - 7.

Using the Belzona solution allowed the original equipment to be used as a former, ensuring a perfect fit. Rebuilding in this way also meant the line was back up sooner than expected.
