BELZONA REPAIRS BROKEN RBC BASE

ID: 758

Customer Location: Waste Water Treatment Plant in Oklahoma

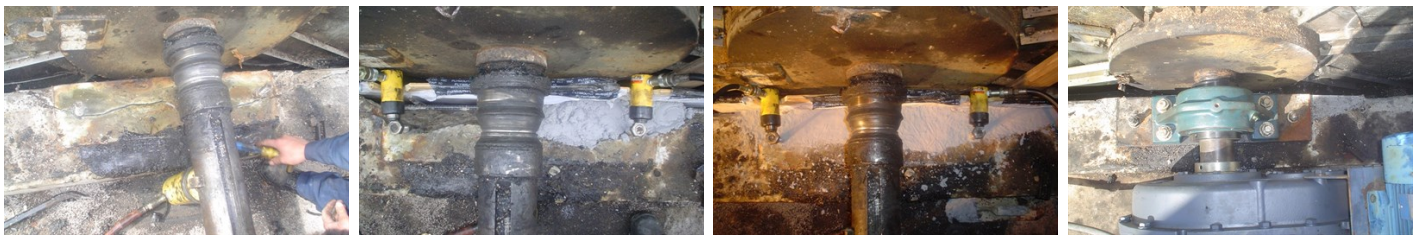
Photograph Descriptions

While replacing the gearbox the customer broke the concrete base and anchors.

* Broken base , * Area prepared & conditioned, backboard in place, anchors aligned, and filling with Belzona® 4111 , * Base filled with Belzona® 4111. , * Completed repair back in operation. ,

Concrete base for gearbox on the RBC (Rotating Biological Collector).

Application carried out in accordance with Belzona Know-How System Leaflet TCC-9.

The customer consulted with Belzona based upon previous successes. Traditional repair would have taken over a month with unacceptable downtime, and cost thousands of dollars. The Belzona repair was completed in a day.
