# Belzona Repairs and Protects Pump Volute in Nuclear Plant

Customer Location: Nuclear Power Station, France  
 Application Date: 2011

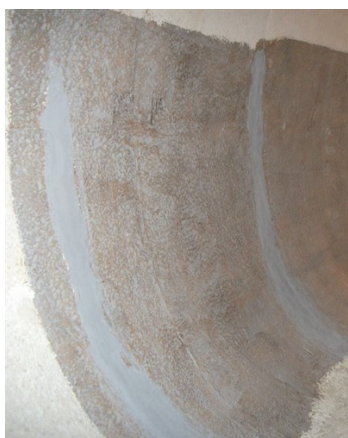
After several years in service, the concrete started to show signs of erosion, showing regular wear and cracking. Repairs were needed, otherwise this wear would have accelerated and risked causing damage to heat exchangers.

- \* 1. Surface preparation. ,
- \* 2. Application of Belzona 4111 in progress to rebuild the concrete wall. ,
- \* 3. Final coat of Belzona 1321. ,
- \* 4. Finished application. ,

The application was carried out in accordance with Belzona Know-How System Leaflet CEP-03. Belzona 4111 and Belzona 1321 were used to repair and protect the walls.

There was no real alternative other than rebuilding with concrete, leaving it prone to the same damage. The repair of the two volutes was done in full respect of the scheduled shutdown of the plant, so without any consequences for the production activity. The pump volute is inspected annually, this was done most recently in 2017 and still found to be in an excellent condition.
