# Concrete Bund Restored

ID: 7588

Concrete bund on a chemical site for catching 98% Sulphuric Acid spills

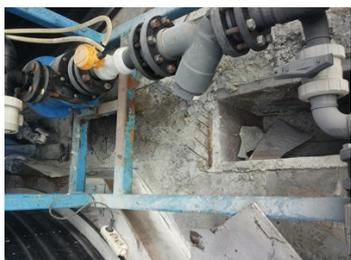
The acid attack had severely damaged the concrete over time, this led to the acid not being

Damaged concrete basement

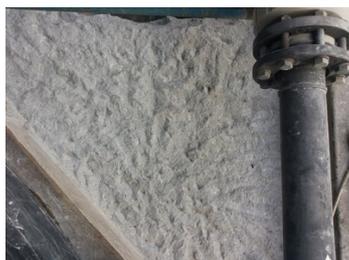
Surface preparation

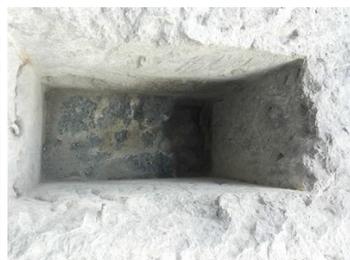
It was necessary to prepare firm surface

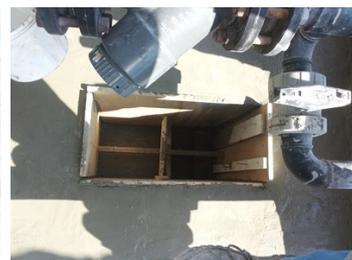
After Belzona application

Application was carried out in accordance with Belzona Know-How System Leaflet TCC-15.
