Pump protection

ID: 7590

Industry: Chemical & Petrochemical
Application: CEP-Centrifugal Pumps
Substrate: Cast Iron
Products: Belzona 1812, Belzona 1391

Customer Location: Chemical company, Slovakia
Application Date: May 2018

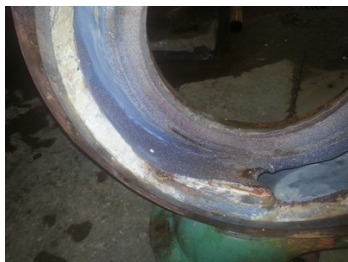
Problem
Erosion/ corrosion

Damaged internal surface of the pump.

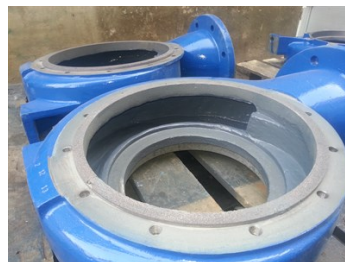
The pump is ready for shipment to the customer.

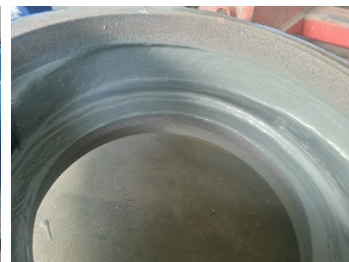
Repair detail with Belzona 1812 and 1391 products

Application was carried out in accordance with Belzona Know-How System Leaflet CEP - 3

Original coating protection - rubber was destroyed in short time. Combination of products Belzona 1812 and 1391 was good solution was this customer. Titanium pumps, which are able to work in these conditions, are very expensive.
