# Belzona Repairs Blower Wheel

ID: 7595

Application: *SHM-Solids Handling Machinery*

Customer Location: *Cement Producer, Slovakia*

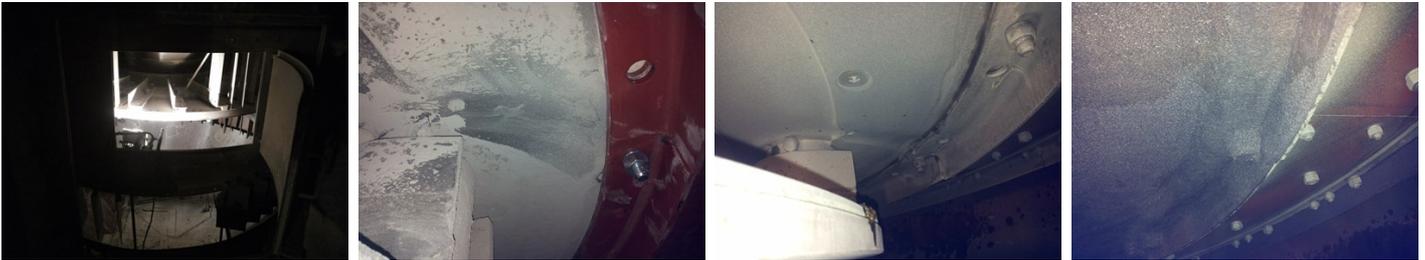
*Where the cement hits some areas of the blower they experienced severe abrasion and erosion. They required an alternative to welding fresh metal plates to reinstate lost material.*

- \* 1. Blower. ,
- \* 2. Damaged areas. ,
- \* 3. After grit blasting. ,
- \* 4. Belzona 1811 application. ,

Application was carried out in accordance with Belzona Know-How System Leaflet SHM-8

In some cases it was not possible to weld new plates as substrate was too thin and in difficult to reach areas. Belzona protection was a faster and more effective solution. It is also easier to maintain in future.
