Belzona Repairs Air Pipe Distributor

ID: 7596

Customer Location: Cement Producer, Slovakia
Application Date: 2016

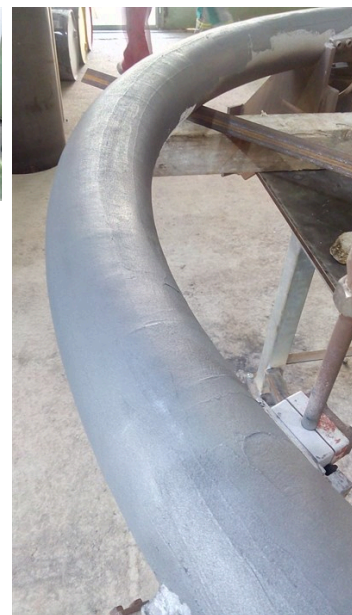
Photograph Descriptions

Whilst the system was offline, condensed gases created corrosion (deep 3 mm) on the DN 125 air pipe distributor.

- * 1. Air distributor after blasting. ,
- * 2. Belzona 1111 plus reinforcement tape. ,
- * 3. Full extent of the pipe. ,
- * 4. Belzona application complete. ,

Due to the size and complexity of the pipe, there was an extremely long lead time on a replacement, as well as considerable costs. The Belzona repair restored strength to the pipe and prevented future corrosion damage.
