Belzona repairs Mould flange

ID: 7597

Customer Location: Aluminium producer, Slovakia,
Application Date: 2014

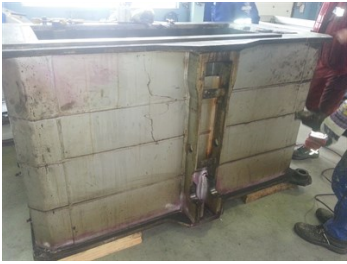
During mould manipulation workers damaged the flange leading to loss of critical dimension.

- * 1. Mould has massive construction ,
- * 2. Surface preparation ,
- * 3. Belzona 1111 application ,
- * 4. Final grinding to achieve correct level ,

Because the mould has massive construction it was not possible to bend sealing face back. Welding would have taken a long time. Repair with Belzona 1111 was done very quickly.
