# Belzona repairs Mould flange

Customer Location: Aluminium producer, Slovakia,  
Application Date: 2014

Mould used in production of anodes.

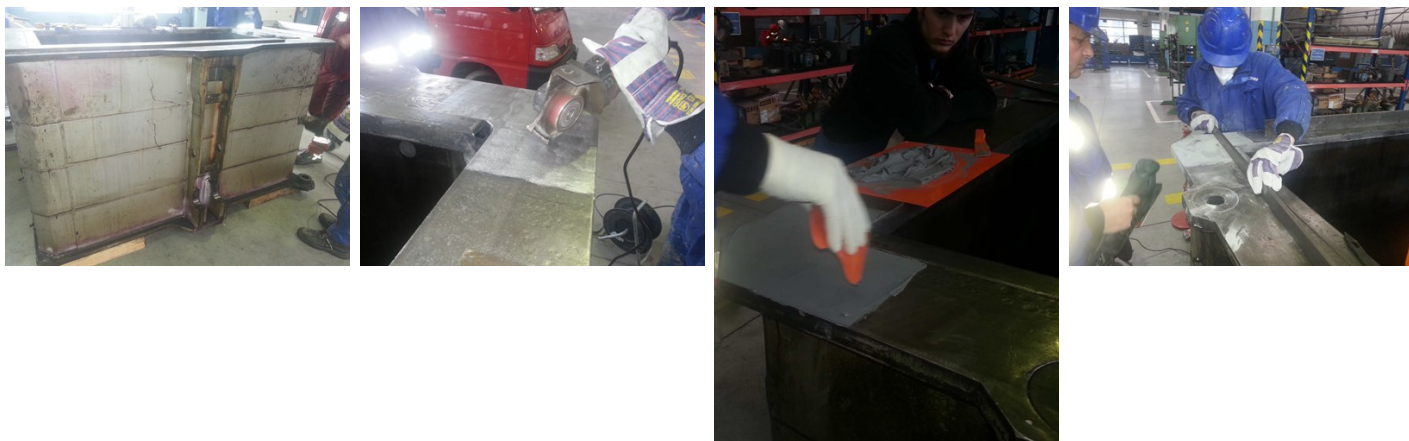
*During mould manipulation workers damaged the flange leading to loss of critical dimension.*

- \* 1. Mould has massive construction ,
- \* 2. Surface preparation ,
- \* 3. Belzona 1111 application ,
- \* 4. Final grinding to achieve correct level ,

Application was carried out in accordance with Belzona Know-How System Leaflet ENC-7

Because the mould has massive construction it was not possible to bend sealing face back. Welding would have taken a long time. Repair with Belzona 1111 was done very quickly.
