# Belzona Pump Seating Repair

Industry: *Steel & Metal Processing*  
Application: *CEP-Centrifugal Pumps*  
Substrate: *Iron casting*  
Products: *\* Belzona 1111 ,*

Customer Location: *Slovakia, metallurgic plant*  
Application Date: *2014*

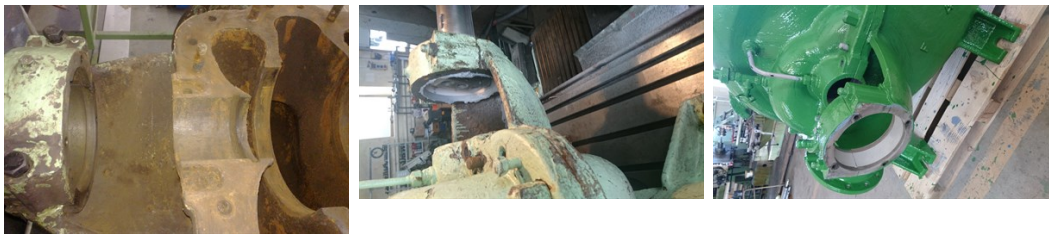
*Corrosion, mechanical damage*

- \* 1. Damaged pump seating ,
- \* 2. Machining of the Belzona 1111 ,
- \* 3. Ready for customer ,

After long time operation the pump has worn down seating. Result is a big clearance of the bearing.

Application was carried out in accordance with Belzona Know-How System Leaflet CEP - 2

Welding of the seating is very difficult, takes a long time. Belzona solution means very good repair and result is that customer uses this Belzona repair also for another pumps.
