Pump repair with Belzona

Industry: *Fluid Flow*
Application: *CEP-Centrifugal Pumps*
Substrate: *Stainless steel*
Products: ** Belzona 1311 (Ceramic R Metal) ,*
** Belzona 1391 (HT) ,*

Customer Location: *Cellulose production plant, Slovakia*
Application Date: *2010*

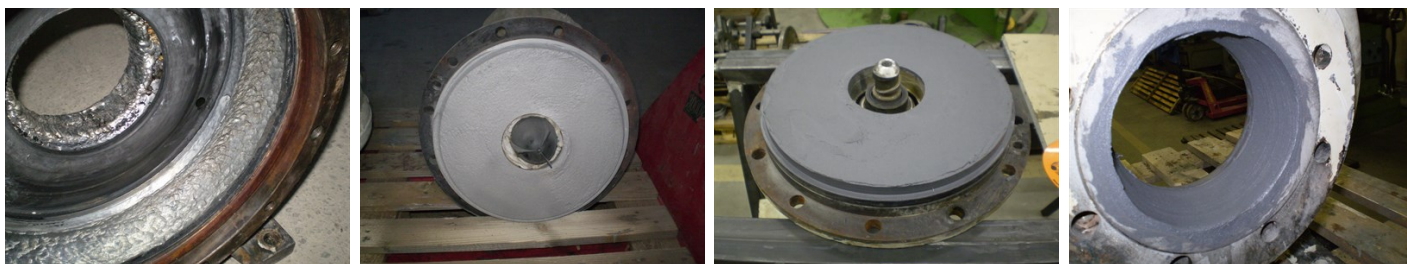
Photograph Descriptions

Corrosion and erosion from chemicals (caustification plus CaCO₃ and CaO)

- * 1. Damaged pump ,
- * 2. After blasting ,
- * 3. Belzona 1311 application ,
- * 4. Belzona 1391 application ,

Application was carried out in accordance with Belzona Know-How System Leaflet CEP - 1, 2, 3
