Slide assembly with Belzona repair

ID: 7606

Industry: *Steel & Metal Processing*
Application: *ENC-Engines and Casings*
Substrate: *Steel*
Products: ** Belzona 1311 ,*

Customer Location: *Slovakia, metallurgic producer*
Application Date: *2014*

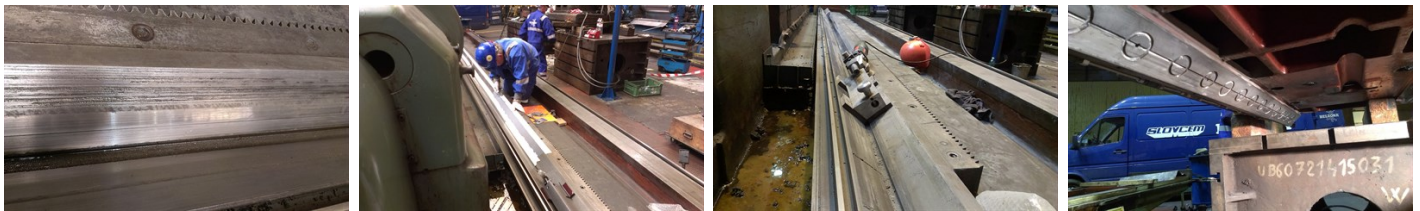
Corrosion accelerated due to the inclusion of water and chemicals within the process

- * 1. Damaged slide assembly ,
- * 2. Belzona 1311 application ,
- * 3. All surface were sanded down ,
- * 4. Support ready to work ,

Slide assembly were damaged from corrosion.

Application was carried out in accordance with modified Belzona Know-How System Leaflet ENC 7.

Belzona was chosen because welding takes very long time with risk of the compromising the structural integrity.
