# Belzona refurbishes Brake test rollers

ID: 7609

Brake test rollers at vehicle testing station.

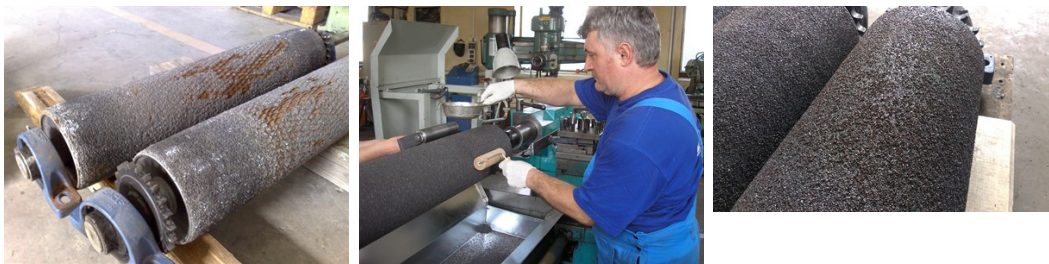
## Photograph Descriptions

*After many thousand tests the surface of the rollers required a new non-slip surface applying.*

- \* 1. Damaged rollers ,
- \* 2. Belzona 9211 Supergrip Aggregate application into Belzona 1821 ,
- \* 3. Ready to work ,

Application was carried out in accordance with modified Belzona Know-How System Leaflet SHM-12.

Customer needed quick repair in good quality and Belzona grip system has a proven track record for this application.
