Belzona refurbishes Brake test rollers

Industry: *Transport*
Application: *SHM-Solids Handling Machinery*

Customer Location: *Vehicle testing station, Slovakia*
Application Date: *2016*

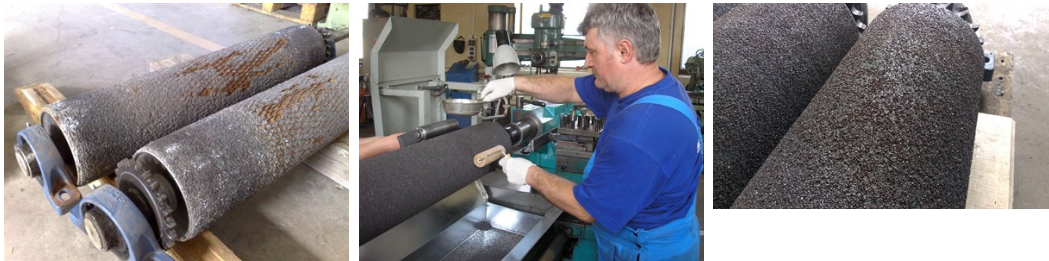
Photograph Descriptions

After many thousand tests the surface of the rollers required a new non-slip surface applying.

- * 1. Damaged rollers ,
- * 2. Belzona 9211 Supergrip Aggregate application into Belzona 1821 ,
- * 3. Ready to work ,

Application was carried out in accordance with modified Belzona Know-How System Leaflet SHM-12.
