Cyclone coating protection with Belzona

ID: 7611

Application: *SHM-Solids Handling Machinery*

Customer Location: *Slovakia, starch factory*

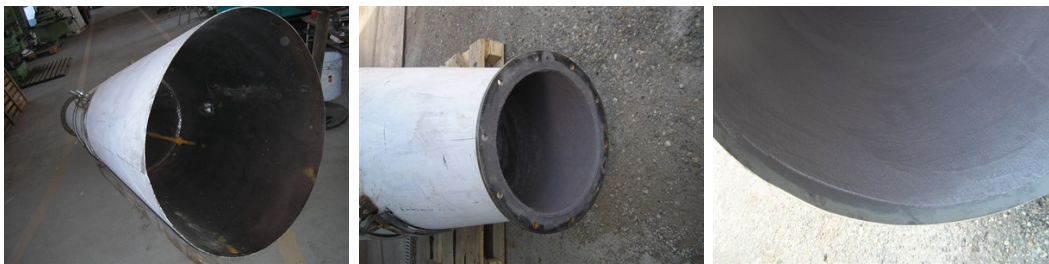
Photograph Descriptions

Damaged cyclone

- * 1. Ready for repair ,
- * 2. Belzona 1812 application ,
- * 3. Belzona 1812 application detail ,

Milled corn material suffers and also adheres on the cyclone surface.

Application was carried out in accordance with modified Belzona System Leaflet SHM- 13

Conventional welding to be out of service too long and also it is not long lasting solution.
