# Belzona repairs joints in concrete

**Industry:** General Industry  
**Application:** FPA-Floor Problem Areas  
**Substrate:** Concrete  
**Products:** \* Belzona 4111 (Magma Quartz) ,  
\* Belzona 2211 (MP Hi-Build Elastomer) ,

**Customer Location:** Furniture production plant, Slovakia,  
**Application Date:** 2015

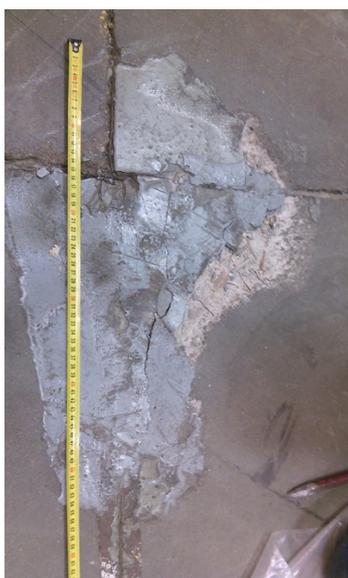
Heavy fork lift truck traffic destroyed joint nosings.

- \* 1. Damaged dilatation joint ,
- \* 2. Repair in progress ,
- \* 3. Belzona 2211 application ,
- \* 4. Joints ready for work ,

Application was carried out in accordance with Belzona System Leaflet FPA-5 and FPA-6.
