# Belzona repairs joints in concrete

**Customer Location:** Furniture production plant, Slovakia,  
**Application Date:** 2015

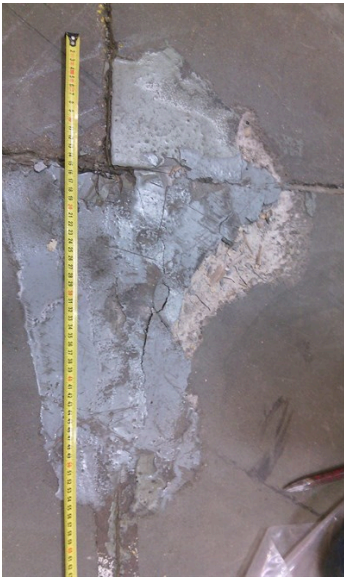
Heavy fork lift truck traffic destroyed joint nosings.

- \* 1. Damaged dilatation joint ,
- \* 2. Repair in progress ,
- \* 3. Belzona 2211 application ,
- \* 4. Joints ready for work ,

Application was carried out in accordance with Belzona System Leaflet FPA-5 and FPA-6.
