# Belzona Extends the Life of Mixing Blades

Application: SHM-Solids Handling Machinery

Customer Location: Plaster Production Factory, Slovakia

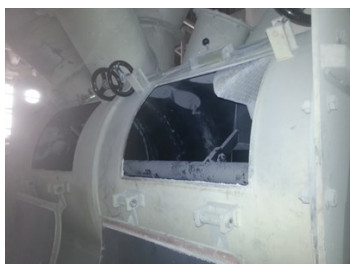
- \* 1. Mixing machine ,
- \* 2. Belzona 1812 and 9811 application ,
- \* 3. Anchor after 12 months mixing ,
- \* 4. Anchors after 4 years in service ,
